TRAULSEN TECHNICAL BULLETIN

HINGE ADJUSTMENT INSTRUCTIONS

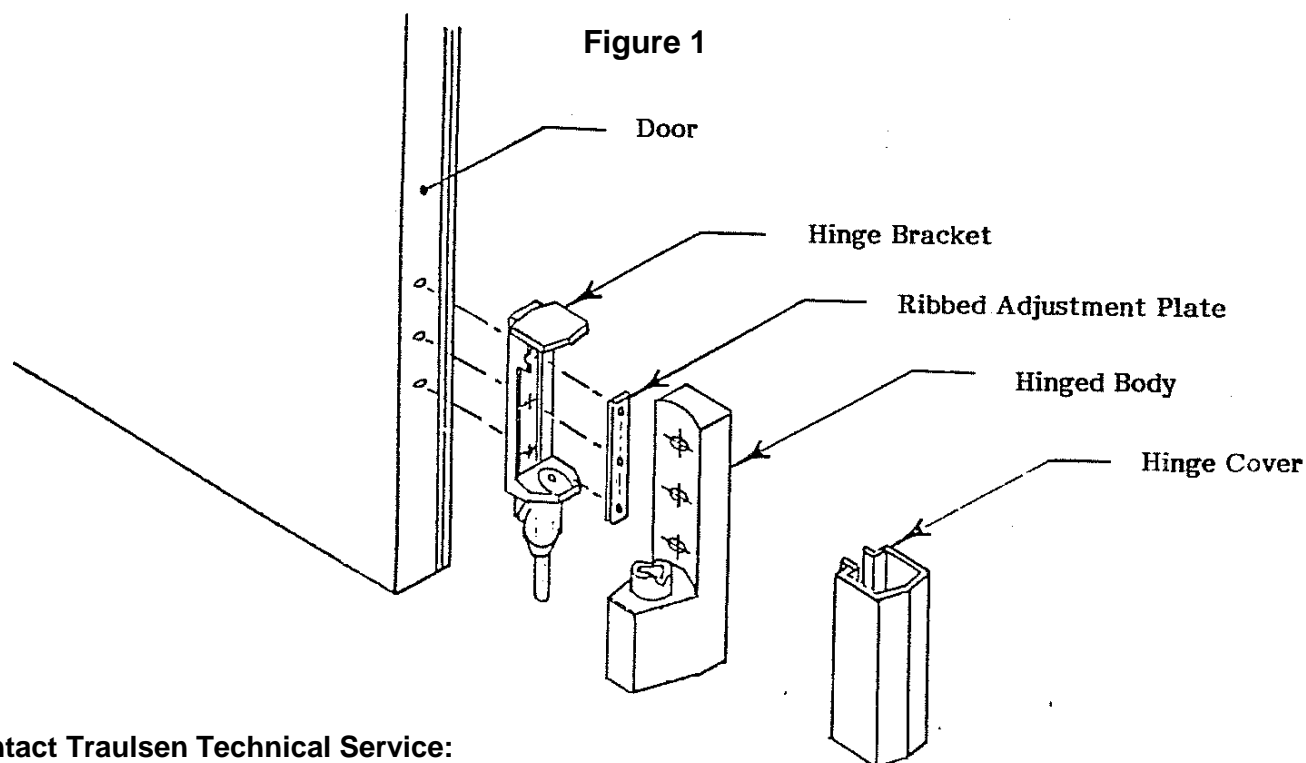
| <ul style="list-style-type: none"> Gasket not seated up against the cabinet face on the handle side of the door. | <ul style="list-style-type: none"> Remove the stainless steel hinge cover from the hinges on the door by using a thin screwdriver to pry the covers away. As seen in Figure 1. Loosen the 3 screws on each hinge. Adjust plate to desired fit and tighten the screws and replace hinge covers. |
